Pedestrian Behavior and Footpath Service Quality in Hilly Tract Region in Bangladesh

Mohammad Kabir Hossain, Md. Tawkir Ahmed and Md. Rakibul Islam*

Department of Civil Engineering, Dhaka University of Engineering and Technology, Gazipur, Bangladesh

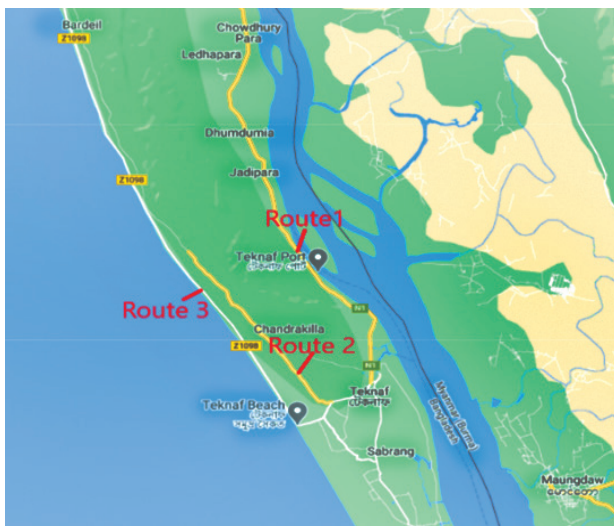
(a) Study routes of Teknaf

Pedestrian survey was carried out in three selected routes (Route 1: Teknaf-Cox's Bazar Road, Route 2: Old Marine Drive Road, Route 3: New Marine Drive Road) between 02/09/2020 to 03/09/2020 (Fig.3). Those routes are selected based on the geographic importance. However, Maximum number of pedestrian pass through those three

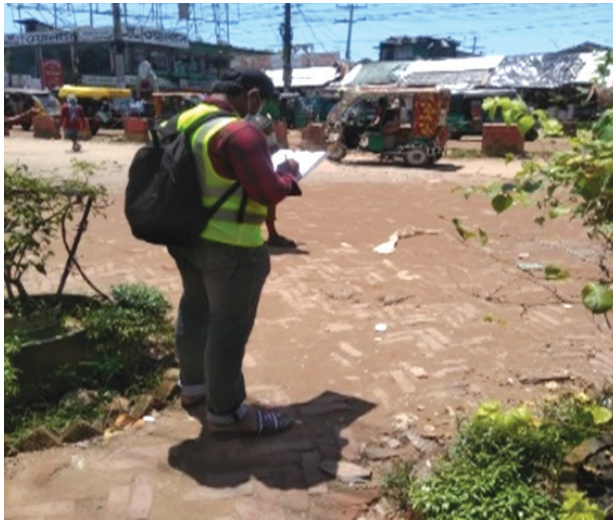
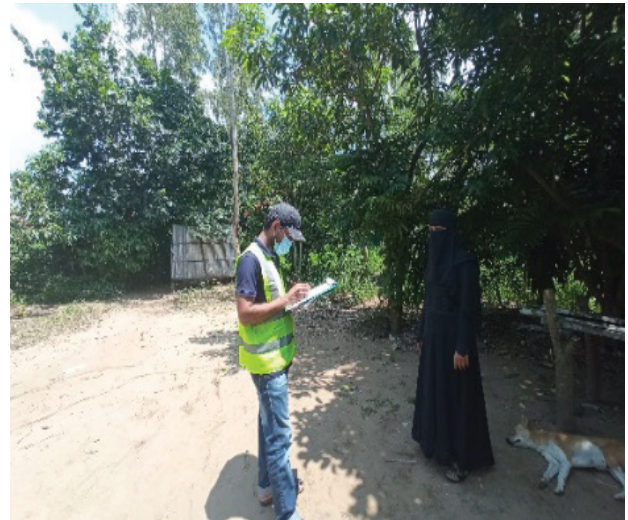
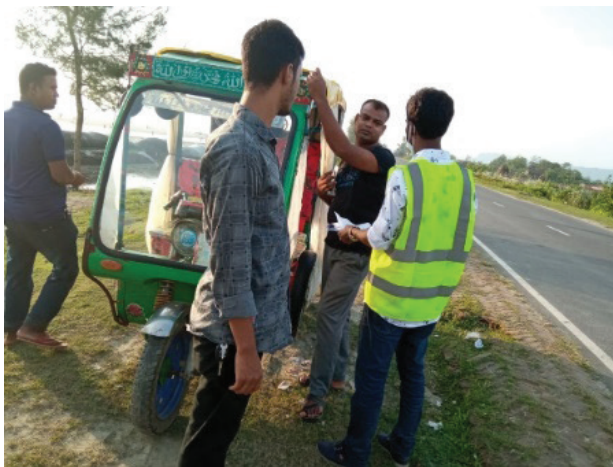
Fig. 4: Pictorial view of pedestrian and footpath condition survey

points (Location 1: Teknaf Bus Stand Point, Location 2: Parjatan Bazar Point, Location 3: Teknaf Beach Point) (Fig.4).

Data were collected in three steps, 1. Pedestrian number was counted in the three important points using counting machine and video camera in a particular segment (5m), 2. Pedestrian speed was counted using speed gun in the three important places, 3. Public opinion about footpath service quality attributes were collected along with their demographic information (Fig.4).

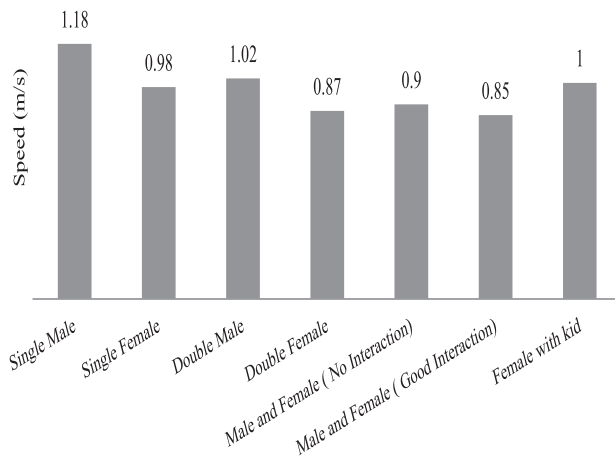
Fig. 5: Average pedestrian walking speed (m/s)

Fig. 5 shows that average walking speed is high for single male and its value is 1.18 m/s. Second highest speed has been observed 1.02 m/s for double male. Lowest Average speed of walking has been observed 0.85 m/s for Male and Female with good interaction (Fig. 5).

For calculation of average walking speed, a strip of 5m was considered and then the time of passing this strip for each category pedestrian was recorded. Average walking speed was calculated using the following formula:

$$V = S/t \quad (1)$$

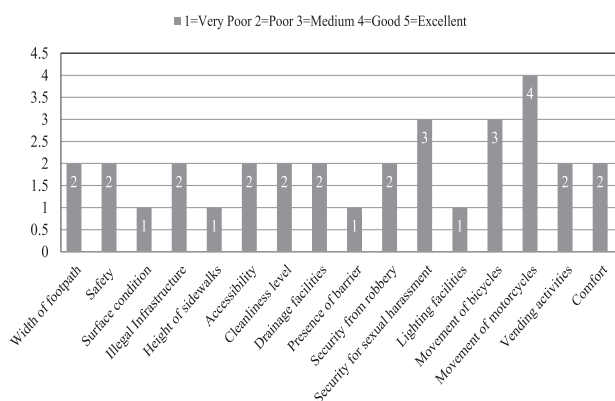
Fig. 11: Footpath attributes survey

Fig. 11 shows the 16 footpath service quality attributes. The attributes were collected based on the Likert scale 1 to 5 rating, where 1 means very poor, 2 means poor, 3 means medium, 4 means good, and 5 means excellent. Movement of bicycles, bicycles and security for sexual harassment are good factors and surface condition, height of sidewalks, presence of barrier, and lighting facilities are in very poor condition. It means that, footpath several factors should be improved on importance basis.

From the study outcomes, the following point can be put forward to improve the present footpath facilities. It will help to fulfill the future demand: 1. Surface condition of footpath need to improve. 2. Height of footpath should be separated from main road. 3. Presence of barrier should be removed on footpath (vendor activities, pothole, construction materials etc.). 4. Sufficient lighting for footpath should be provided especially for night condition.
