Socio - Economic Impact of Erosion along the Right Bank of the Jamuna River in Bangladesh

Mohammad Nazim Uddin¹ and Md. Munsur Rahman²

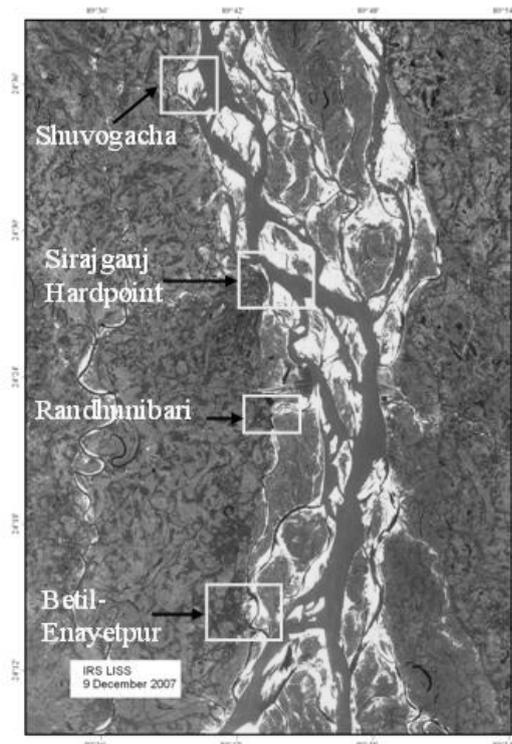
Fig. 1: Study sites.

To study on socio-economic impact of erosion four sites were selected within 40 km reach along the right bank of the Jamuna River. Shuvogacha under Kazipur Upazila, an erosion vulnerable area, is situated about 25km upstream of the Bangabandhu Bridge. The Sirajganj town is about 8 km upstream of the Bangabandhu Bridge, Randhunibari under Belkuchi Upazila is about 2km downstream and Betil-Enayetpur under Chowhali and Belkuchi Upazila respectively is about 15 km downstream of this bridge. The four study sites are shown in Fig. 1.

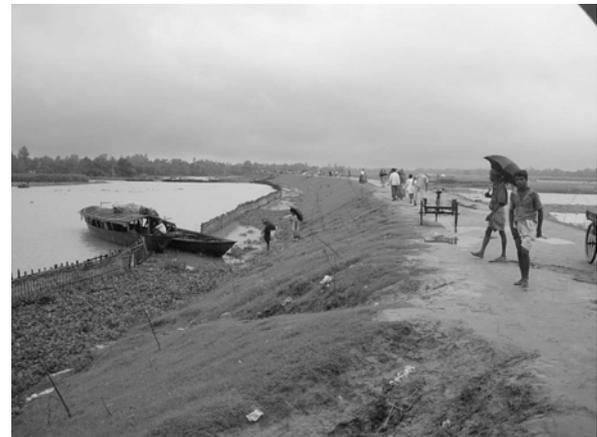
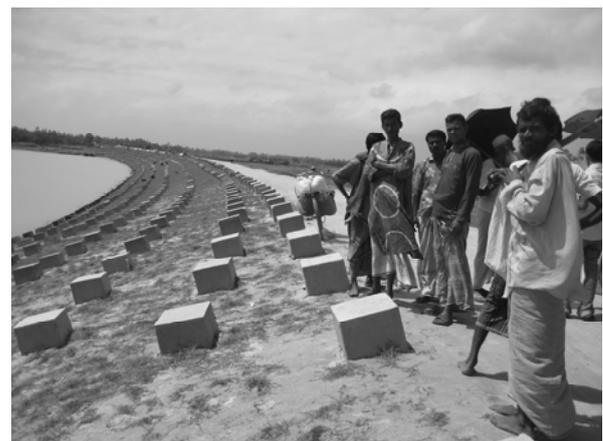
Fig. 2: BRE is protected by erecting bamboo or geotextile with concrete block at Shuvogacha.

Brahmaputra Right Embankment (BRE) was at a distance about 400m from the bankline of the Jamuna River at Shuvogacha bend in 2008. Some portion of the bank gets inundated during the flood season. At that time, the flow of the river directly hit to BRE. But according to the early practice, the BRE was protected from wind wave action by

erecting bamboo as shown in Fig. 2(a) in 2008. Later, the river side of the BRE was protected by geo-textile with cc blocks as shown in Fig. 2(b) in 2009. The homesteads and crop lands are being eroded into a secondary channel (i.e. Shuvogacha branch channel). Bank erosion and char formation is the regular phenomena at the Shuvogacha bend.

(a) 2008

(b) 2009
